The Risk of Flying Manhole Covers

Ir Simon NGO

The Hong Kong and China Gas Co. Ltd.

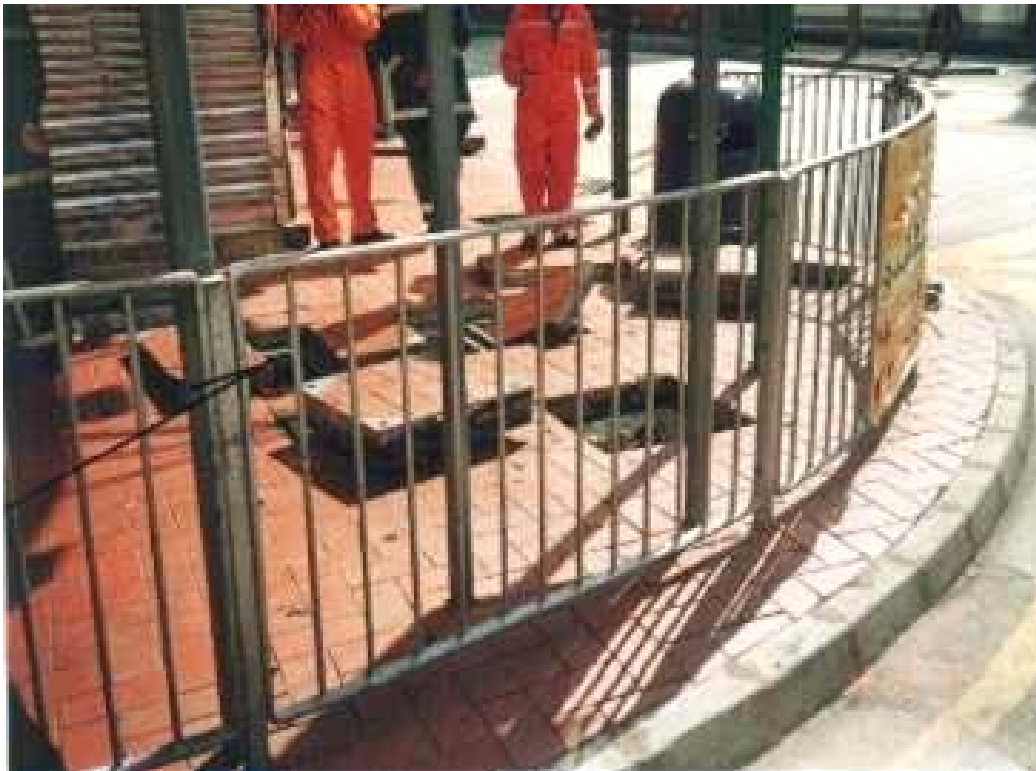
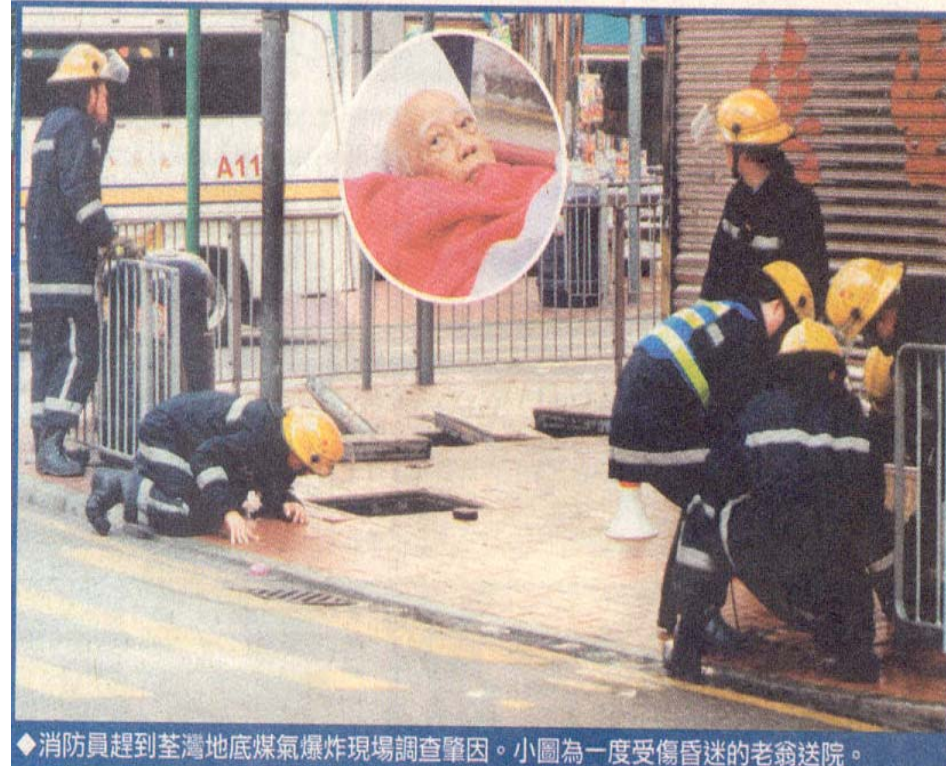
Telecom Manhole Blasting at Chung On St on 12/01/2003

- 2 manholes, 8 covers
- Gas leak due to road settlement
- 4 injuries

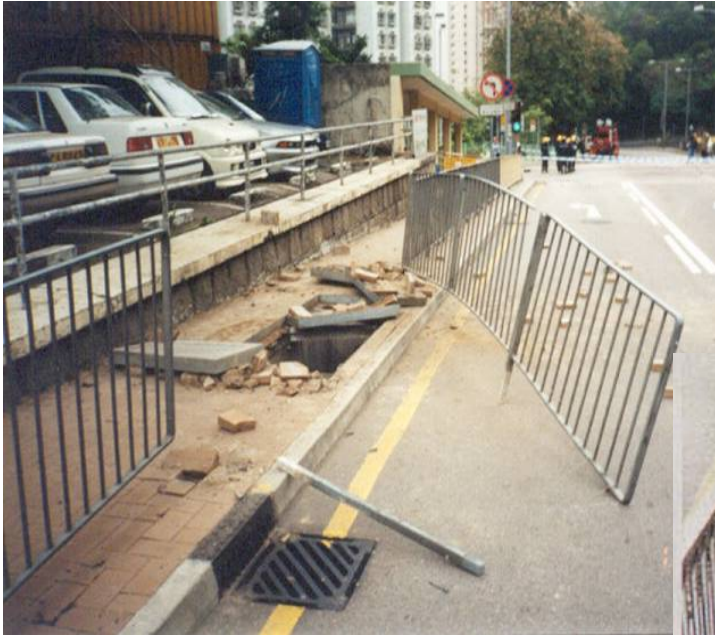
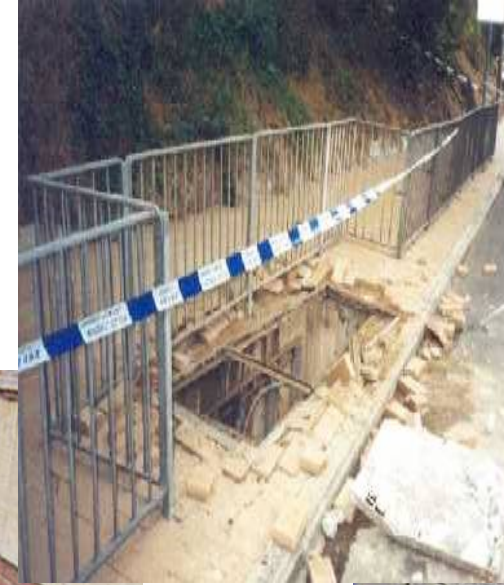
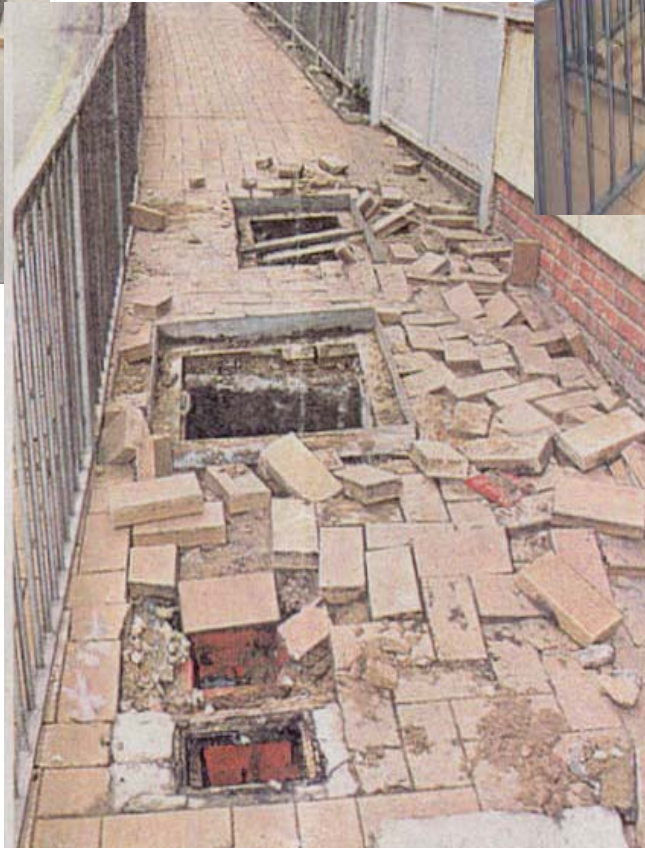
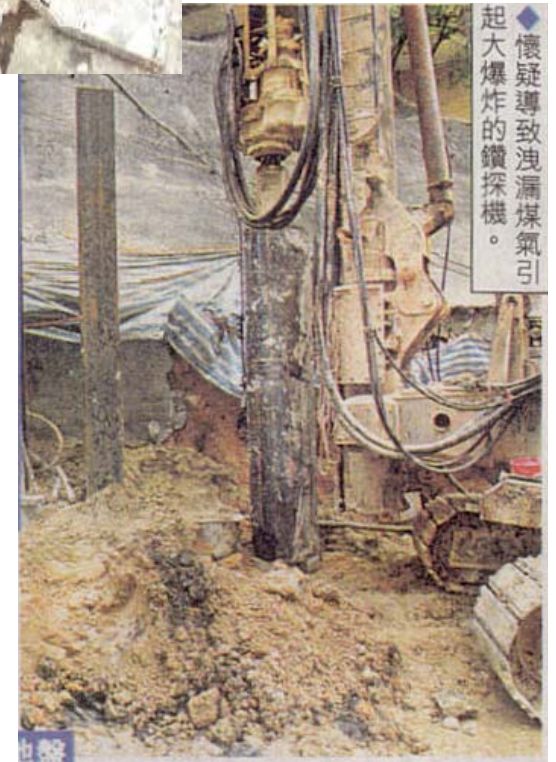
Telecom Manhole Blasting at Pokfield Rd on 13/02/2003

- 6 manholes, 14 covers
- Gas leak due to 3rd party damage
- 2 injuries

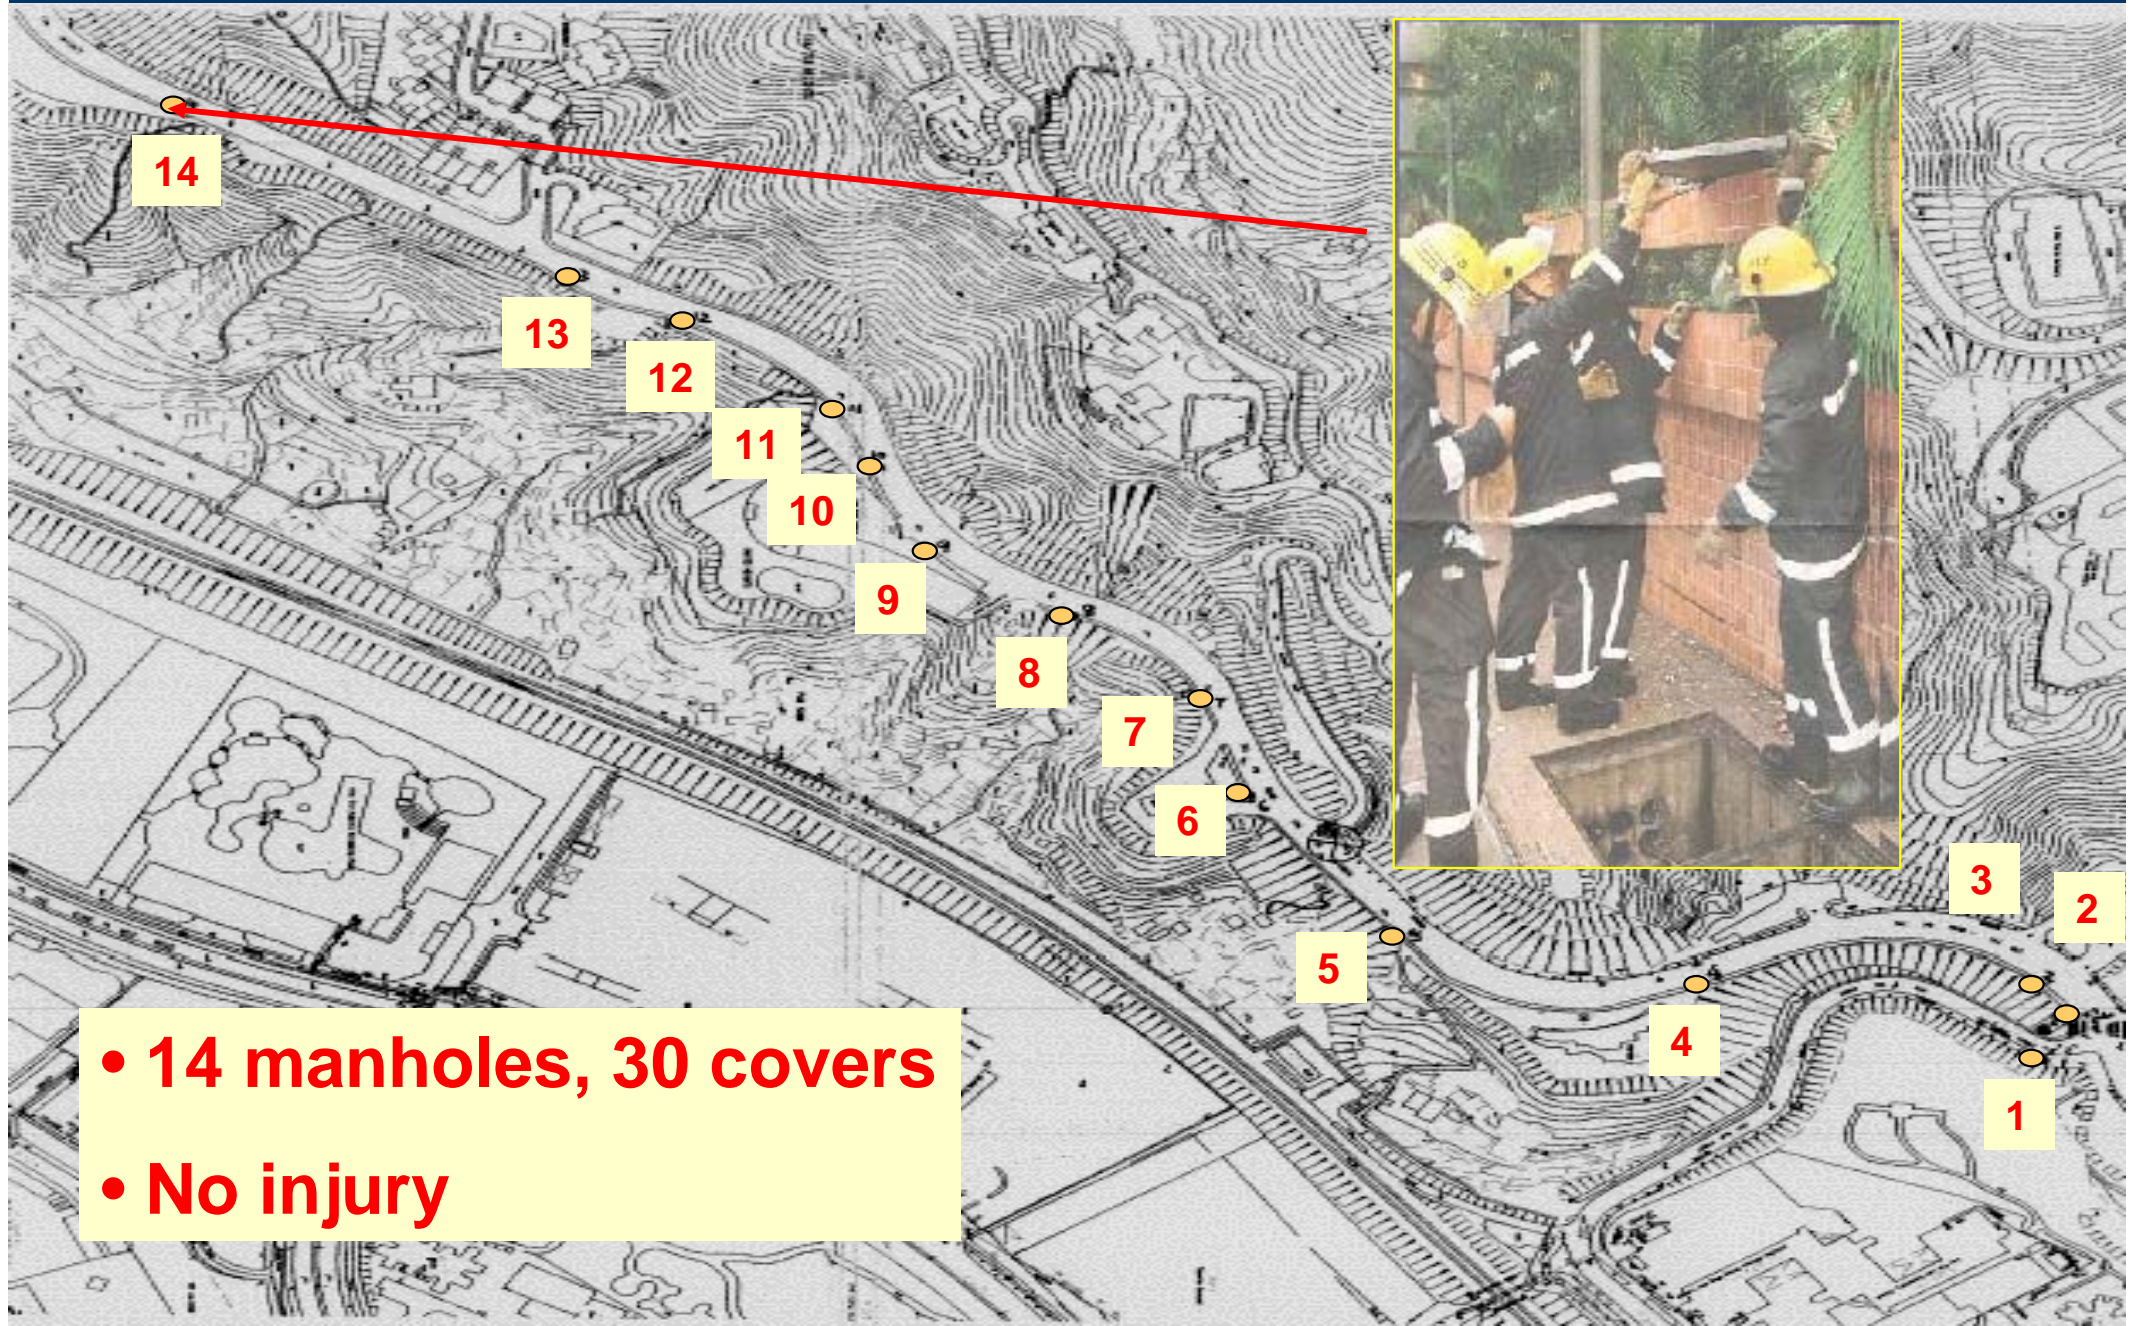
Telecom Manhole Blasting at Chik Wan St Due to Unidentified Gas on 17/04/2004

- 14 manholes, 30 covers
- No injury

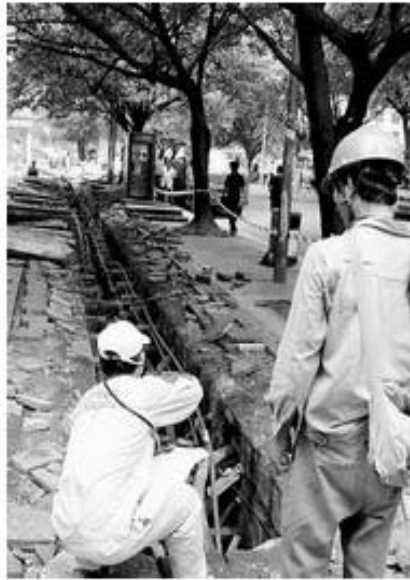
Damage to underground LPG pipe

本报深圳今日电（记者于明山）昨日0时10分左右，深圳市深南大道与华富路附近，一施工单位在修建地下通道时违章施工，造成直径110毫米的地下燃气管道泄漏引起爆炸。事故中1人死亡，16人受伤。在16名伤员中，有6名围观者，唯一死亡的女性也被判断为围观市民。

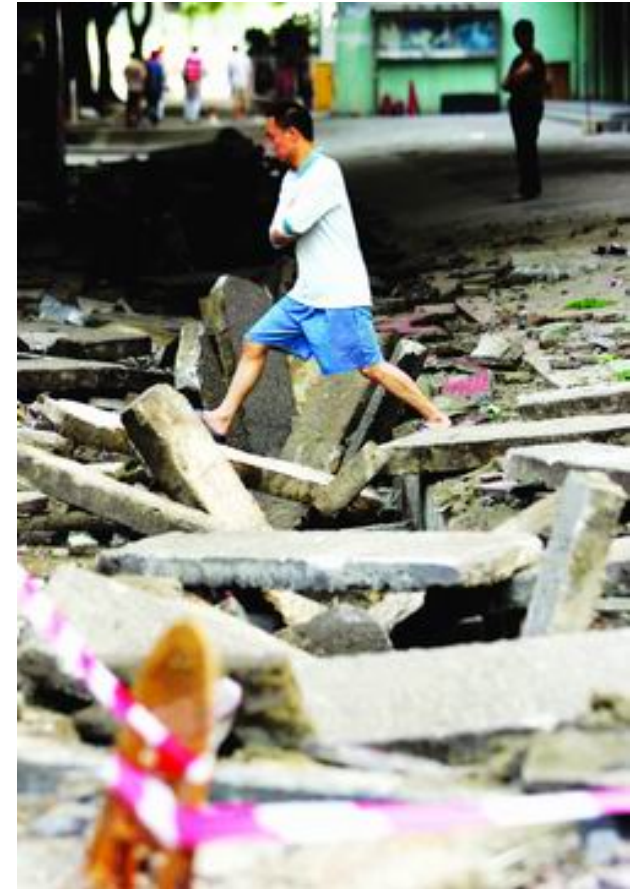
A flying cover hit a passer-by and killed her instantly

The escaped LPG entered into the nearby ducts, manholes and cable troughs resulting in a number of **cascaded explosion** blowing up the covers

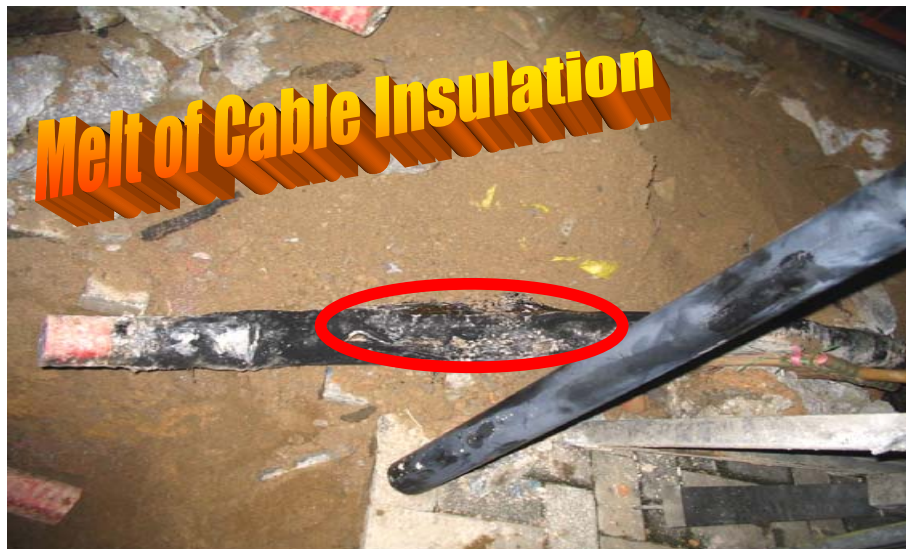
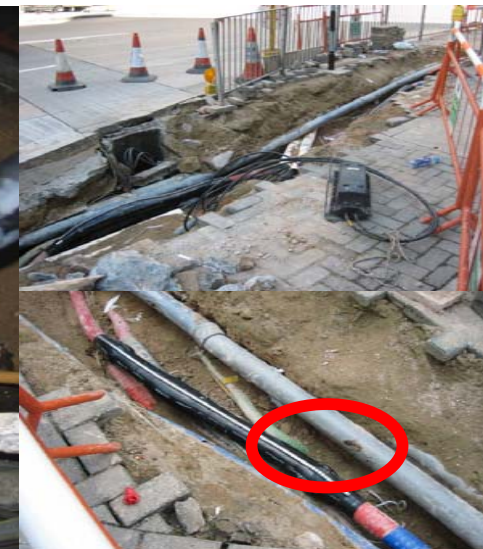
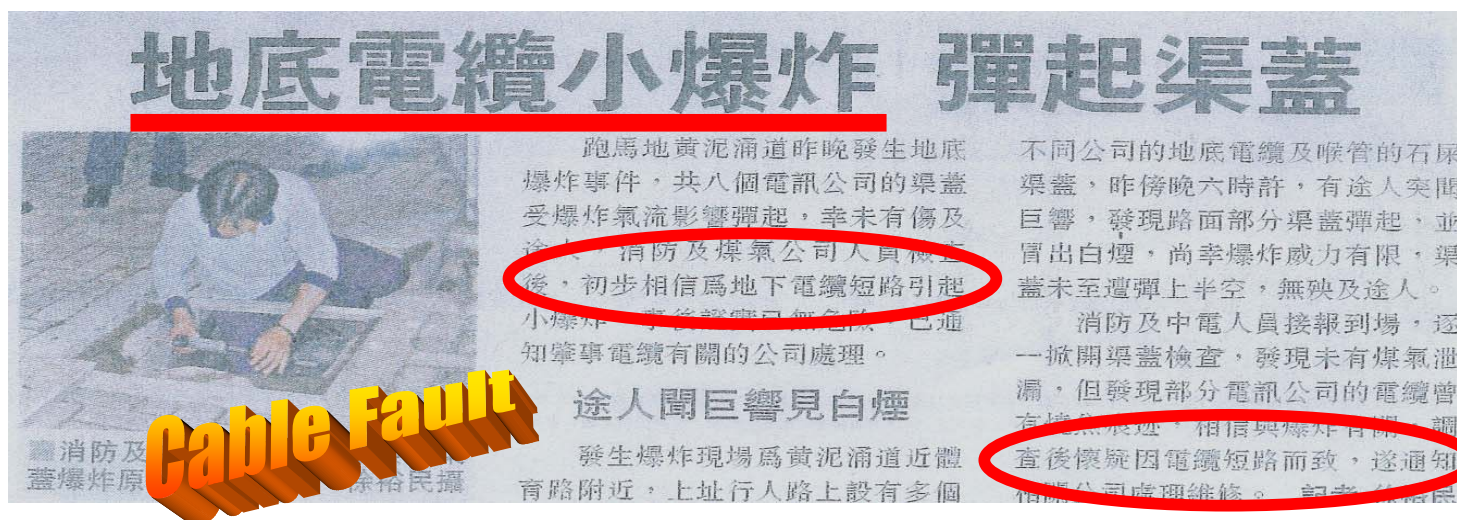
Suspected Power cable fault created air pressure or evolution of combustible gas and led to explosion.

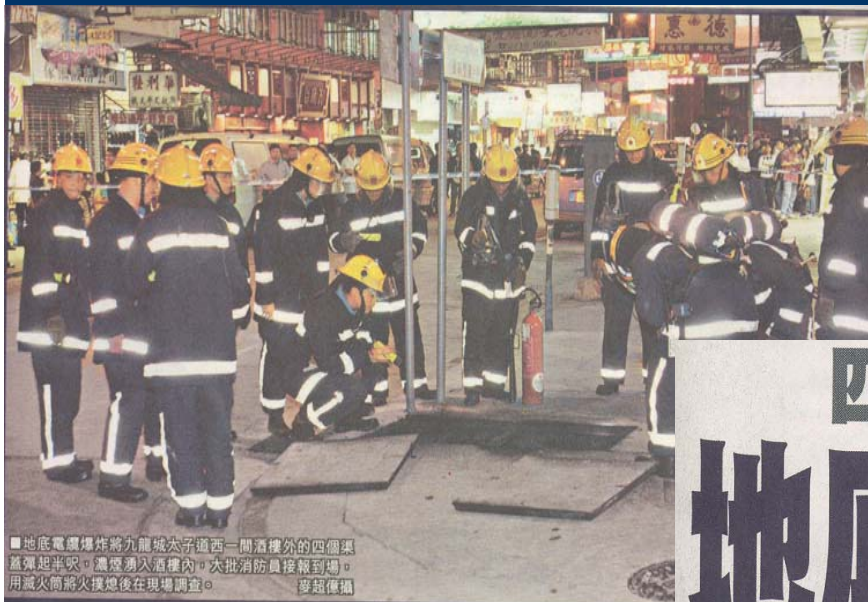
Suspected Power cable fault generated combustible gas and caused explosion after triggering by ignition sources.

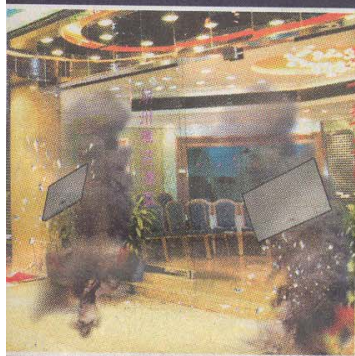
九龍城地底電纜爆炸
示意圖

地底電纜爆炸將渠蓋彈起，大量濃煙從渠口冒出湧入酒樓，數百食客紛紛走避，五名酒樓職員吸入濃煙不適

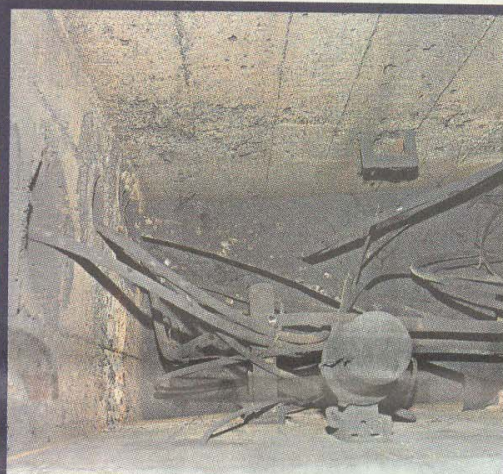
發生爆炸的地底電纜被火熏黑。
