IR Filter Bonding Reliability of Camera Module for Mobile Phone

Yang Ho Moon, Hee Seong Choi, Seung Su Park

OS Precision Advanced Technology Group
/ Solution Creating Group, R&D Center
/OS Precision Optical Special Tool Group
Samsung Electro-Mechanics

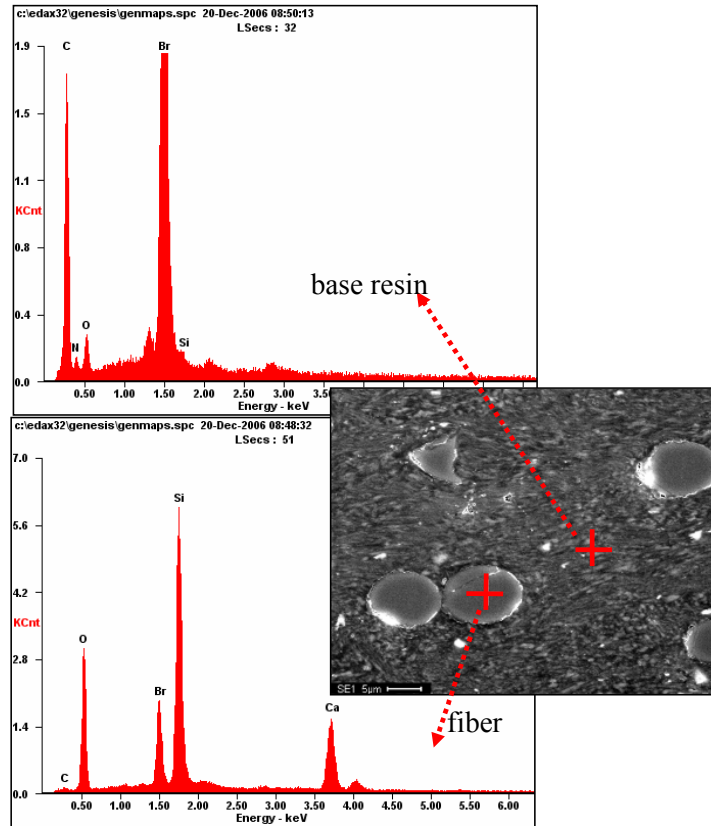
(a) failure sample

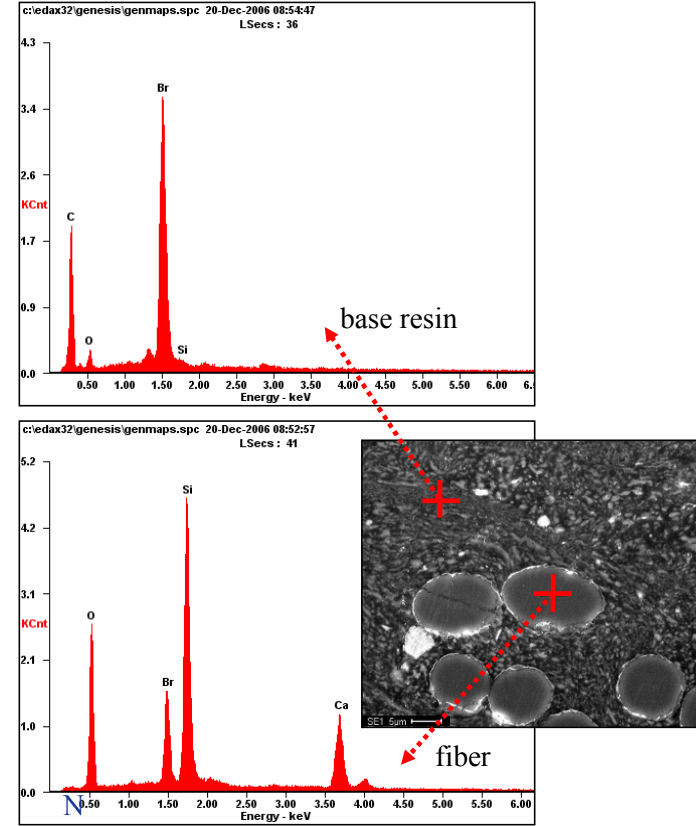
(b) success sample

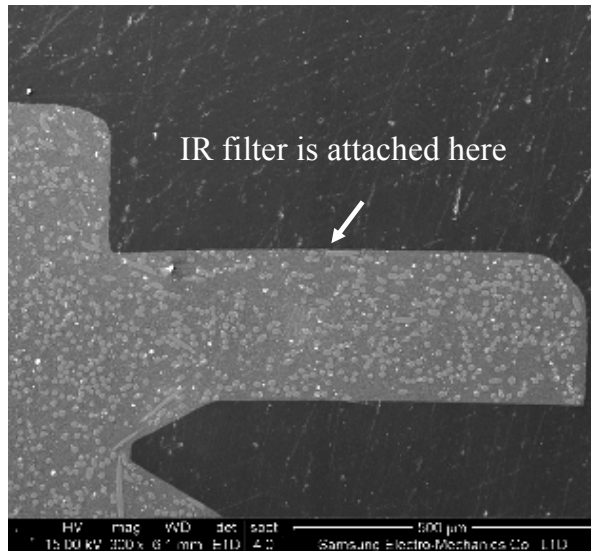
(a): failure sample (fiber 26%)

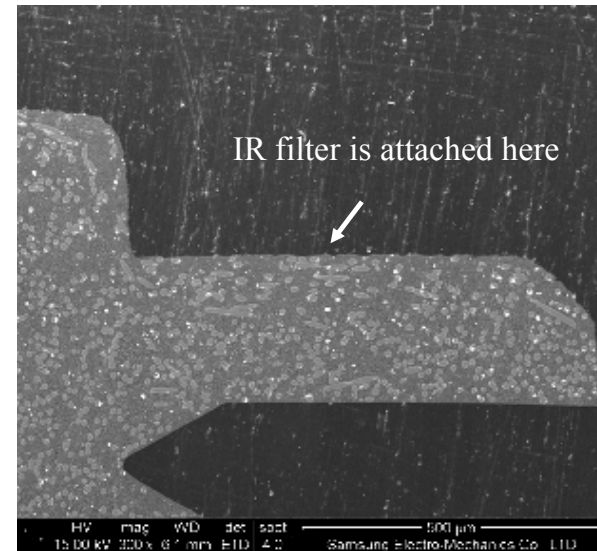
(b) : success sample (fiber 27 %)

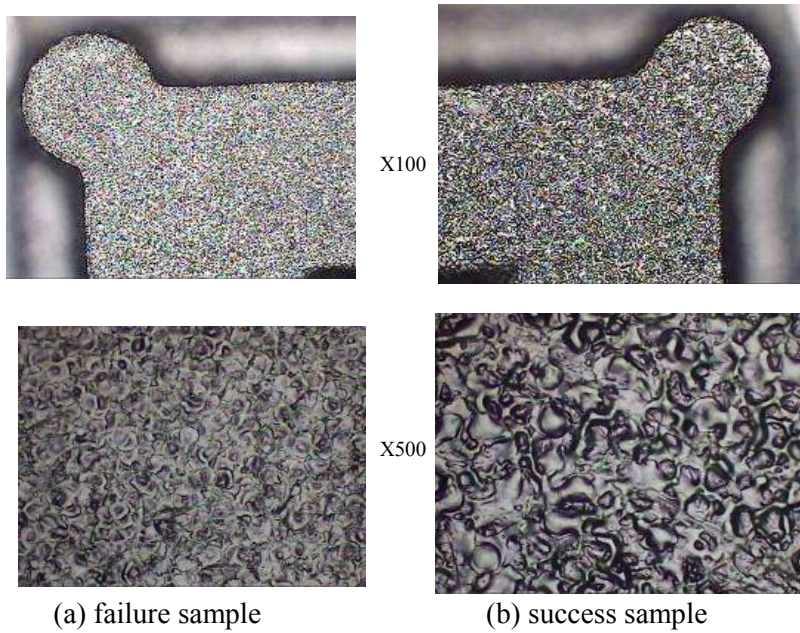
SEM pictures of housing Surface

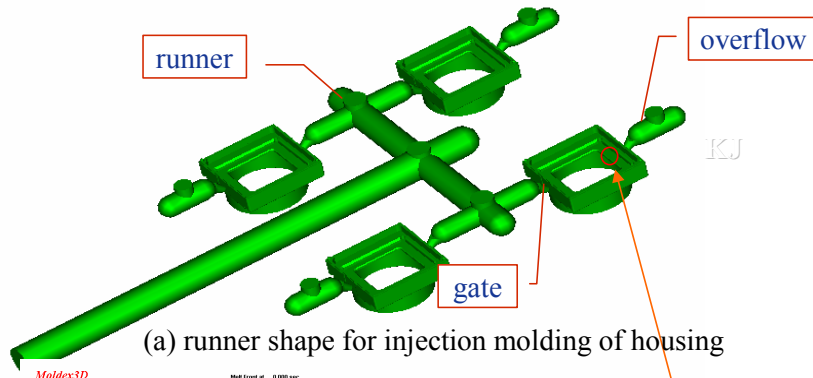
(a) runner shape for injection molding of housing

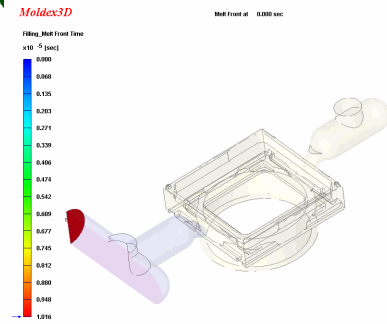
(b) Filling pattern

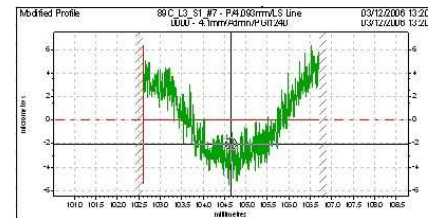
The detached place between IR filter and housing

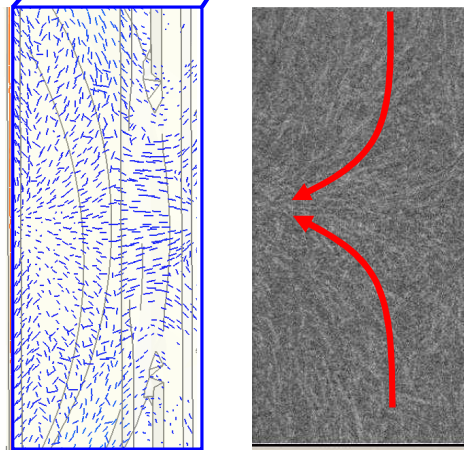
Failure Mode I

(b) simulation

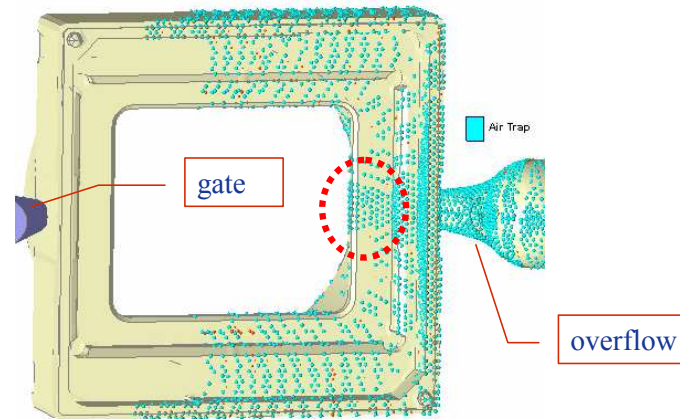
Air Trap (simulation, Failure Mode I)

<p>1) <u>Over flow part</u> of 1 point gate injection mold for housing has <u>air trap</u> and <u>surface profile</u> is not straight 2) <u>Humidity</u> go through the over flow part 3) <u>thermal stress</u> applied 4) <u>RMS(surface roughness)</u> of housing surface is low, so <u>bonding strength</u> is low. 5) UV bond is detached</p>	<p>1) two point gate injection mold. 2) U shaped surface profile (Pt=7μm~17μm) 3) Make surface rougher (RMS 1.3μm \rightarrow 2.2μm)</p>
<p>2</p>

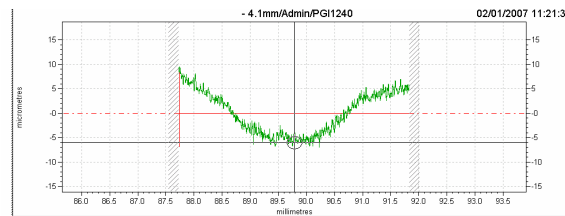
Surface Profile of housing surface that IR filter is attached (Pt: 7~16 μ m)

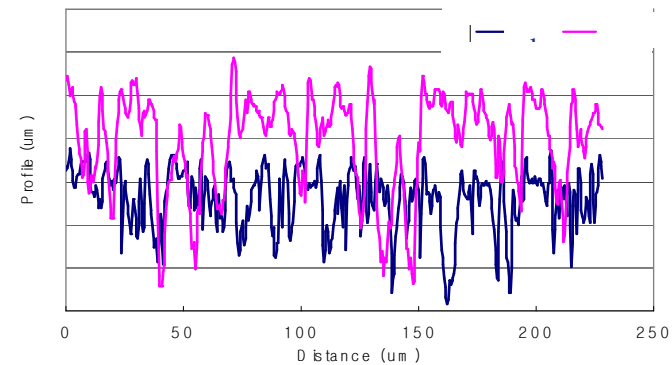
Surface roughness of housing surface that IR filter is attached ((a): initial state :RMS 1.3 μ m, (b): improved state : RMS 2.2 μ m)

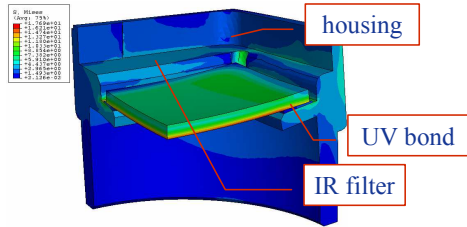
Thermal stress distribution as a result of thermal Stress Analysis

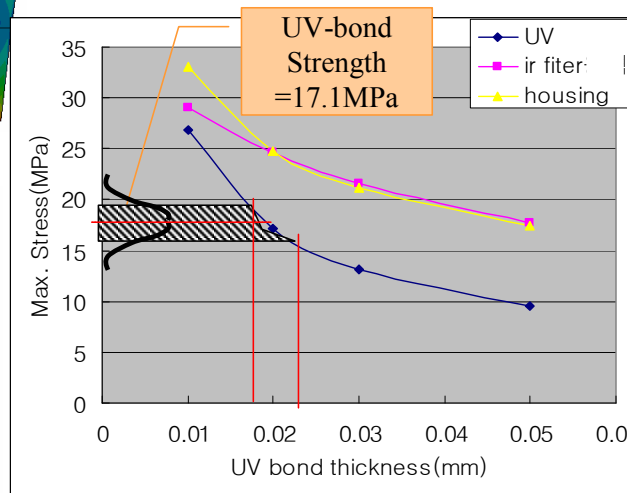
Graph of maximum stress according to UV bond thickness

<p>1) <u>thin</u> UV bond thickness 2) <u>thermal stress</u> is higher than bonding strength 3) UV bond is detached</p>	<p>UV-bond thickness > 0.023mm</p>
<p>3</p>

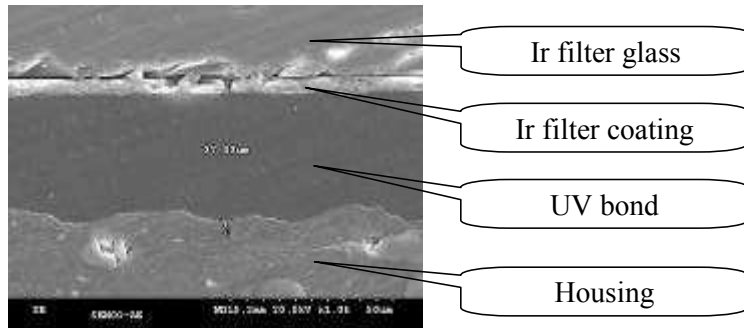
UV-bond thickness	Sample number	Success sample %
~0.015mm	12	0%
0.025~0.035mm	12	100%
0.035mm~	12	100%

SEM picture of cross section for IR-filter attached housing

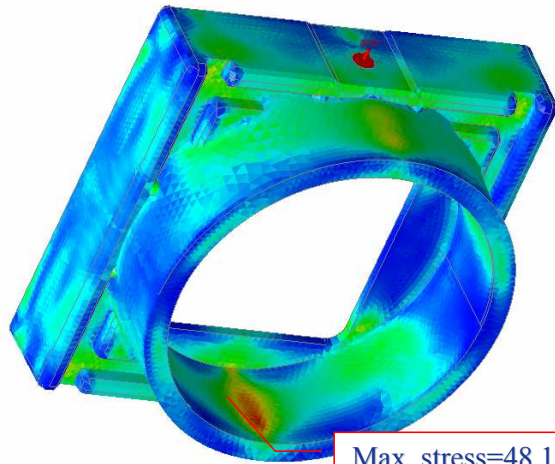
(a) Pressure 1000kg_f/cm², period=1.2sec

Stress distribution of housing after injection molding process
(Red: high stress, blue: low stress)

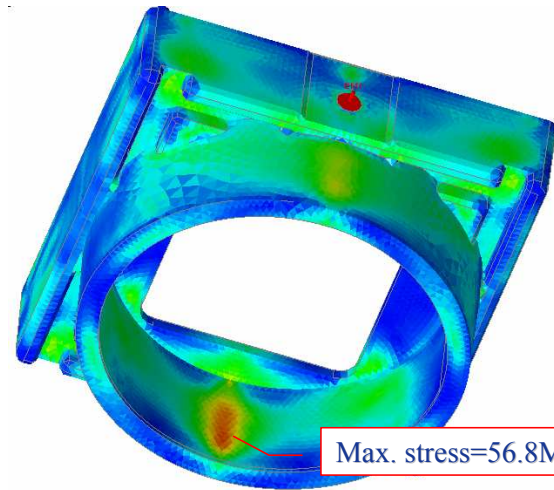
(b) Pressure 1400kg_f/cm², period=1.5sec

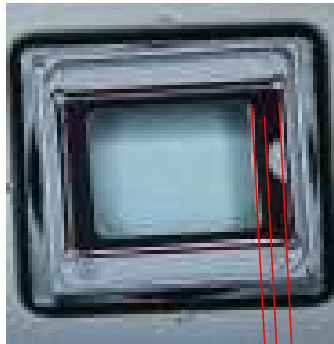
failure sample after the reliability test
